MEMOIRS OF THE
ARCHAEOLOGICAL SURVEY OF INDIA
NO. 91

ANGKOR VAT

INDIA'S CONTRIBUTION IN CONSERVATION

1986-1993

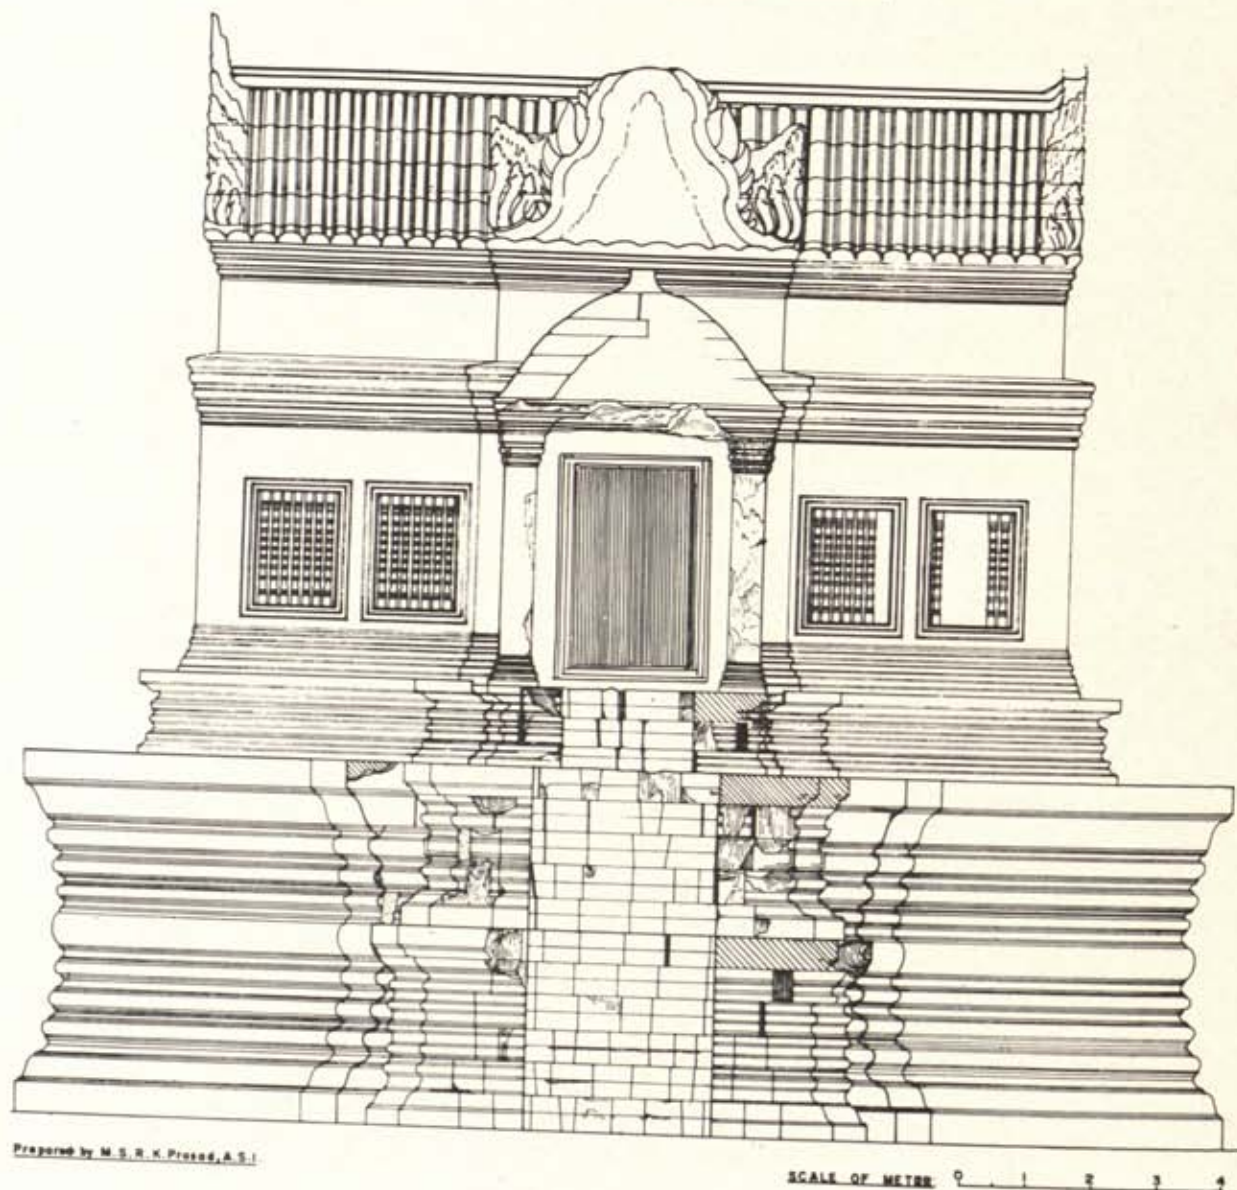
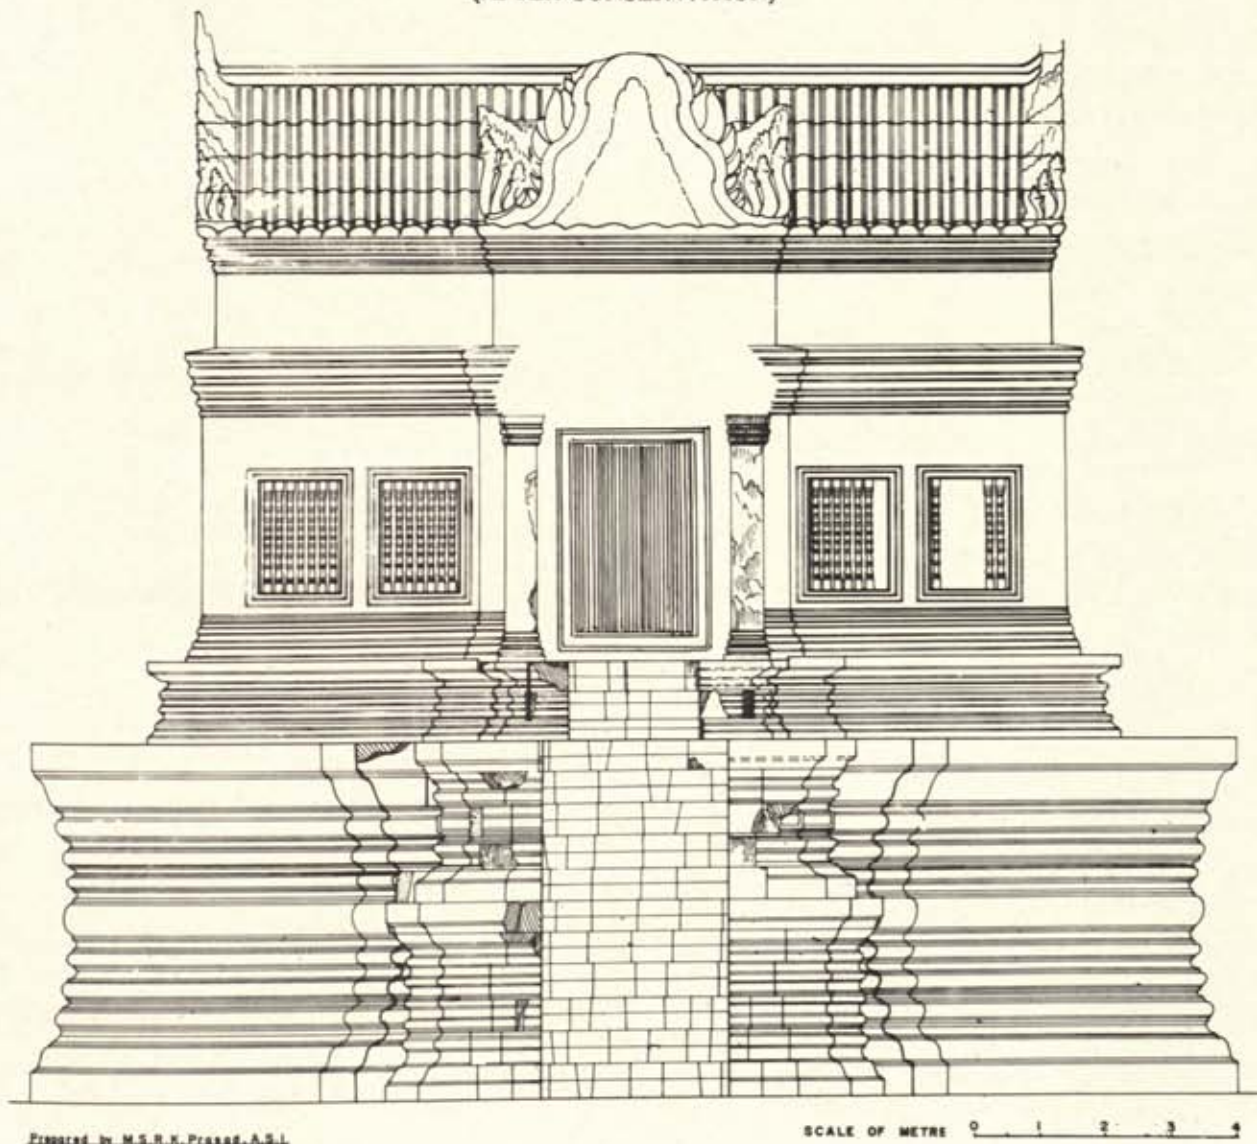
NORTHERN CENTRAL ENTRANCE PORCH OF SECOND ENCLOSURE
(BEFORE CONSERVATION)

NORTHERN CENTRAL ENTRANCE PORCH OF SECOND ENCLOSURE
(AFTER CONSERVATION)
